NBS BUILDING SCIENCE SERIES 145

Investigation of Construction Failure of Harbour Cay Condominium in Cocoa Beach, Florida

Based on the results of this investigation, it is concluded that the most probable cause of the failure was insufficient punching shear capacity in the fifth-floor slab to resist the applied construction loads.

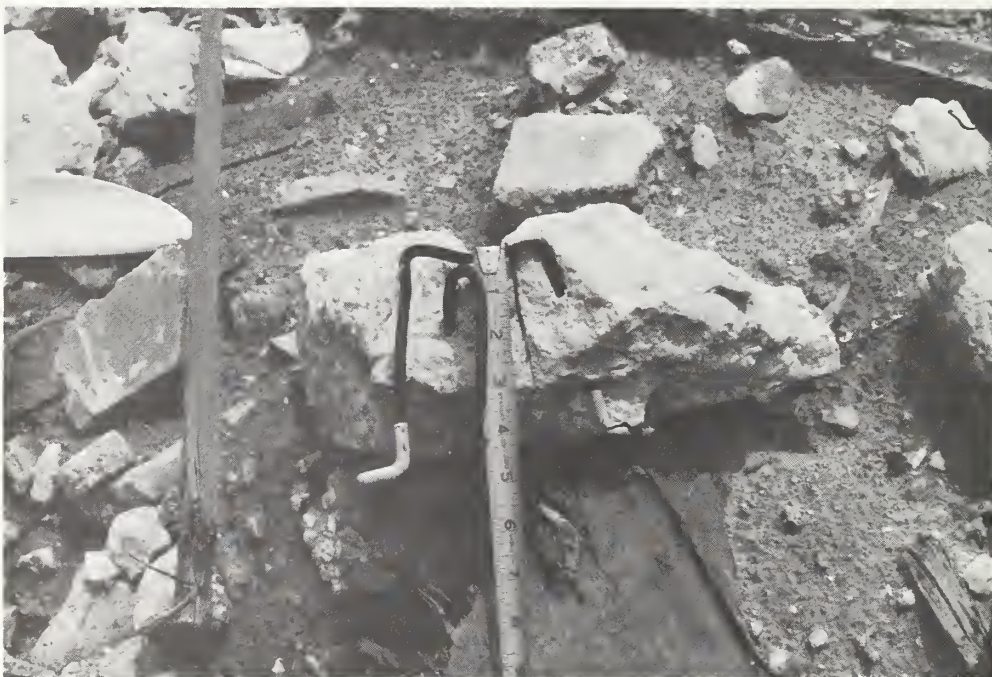
It is shown that high punching shear stresses resulted from use of reduced height individual high chairs to support the top reinforcing bars in the column strip, thereby reducing the effective depth of the slab. The omission of a check for punching shear capacity in the design calculations resulted in a slab thickness of 8 in (203 mm). The ACI Code would have required a thickness of 11 in (279 mm) to provide adequate safety against punching shear under design loads. It is shown that this design deficiency resulted in a reduction of the margin of safety such that the slab had insufficient reserve strength to accommodate construction errors.

Figure 2.5 Field measurement of chair heights for top bars in column strip

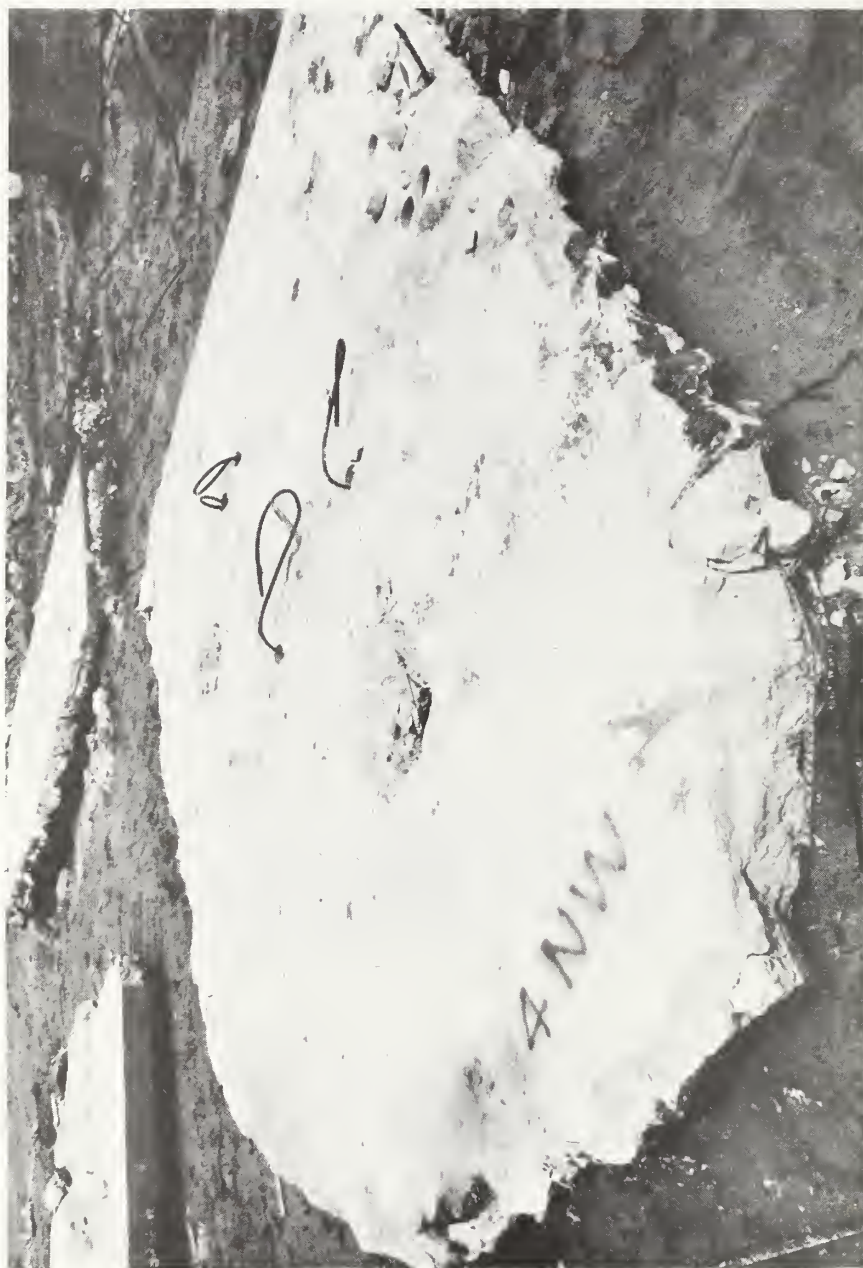
Figure 3.1 An identified portion of slab removed from the north-west section of the fourth floor

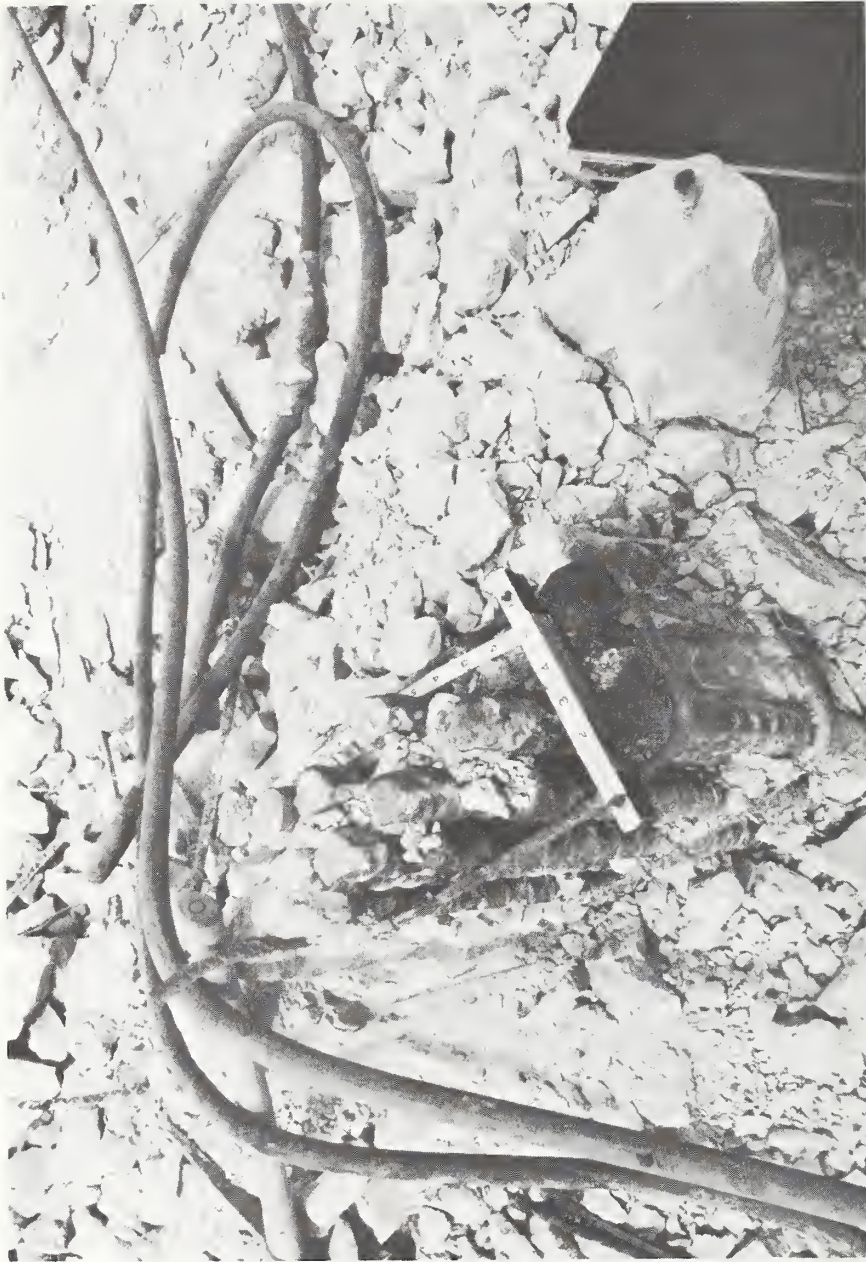
It was also noted from the first-story column sections still standing on the ground level that where 8- # 10 or 8- # 11 bars were lapped, in a 10 x 18 in (250 x 460 cm) column section, the total steel area exceeded considerably the maximum limit of four percent of the gross area of the concrete allowed by the ACI Code [2.1]. As shown in figure 3.3, the vertical reinforcement was so congested that there was hardly any space left between adjacent bars to allow the flow of concrete during placement.

Figure 3.3 Congested reinforcement in a first-story column
